# An Operational Field Test Of Long Combination Vehicles Using ABS And C-Dollies

Volume I

Fuel Technical Report

UMTRI-95-45-1

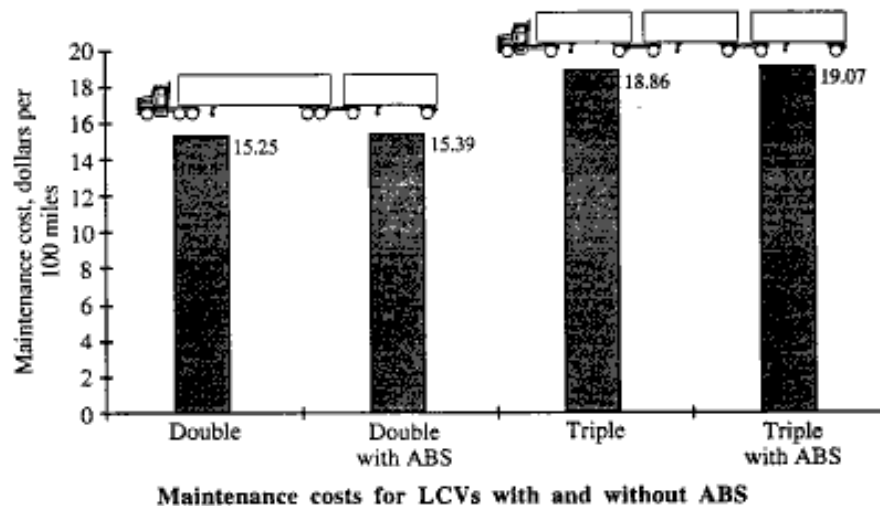
**Maintenance cost for ABS on individual units of LCVs**

Introducing ABS on all units of a typical double- or triple-trailer combination vehicle was found to increase the maintenance expense of the entire vehicle by about 1 percent. The cost of maintaining ABS on trailers and dollies appears to be about 3.2 cents per unit per one hundred miles traveled. This represents about 1 percent of the maintenance costs of a trailer and about 3 percent of those costs for a dolly. The figures for tractors are 4.5 cents per one hundred miles and 0.5 percent of the maintenance expense of the unit.

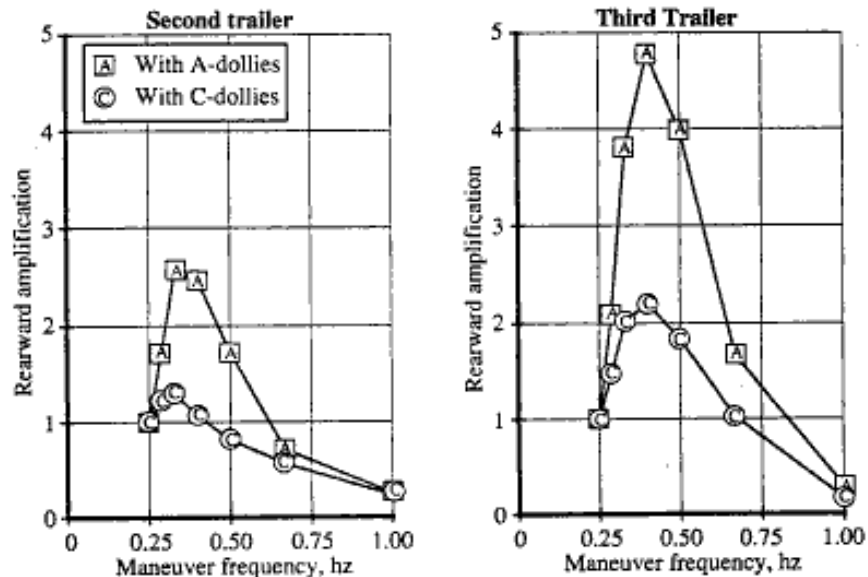
Rearward amplification measured on fully loaded triples (55-65 mph)

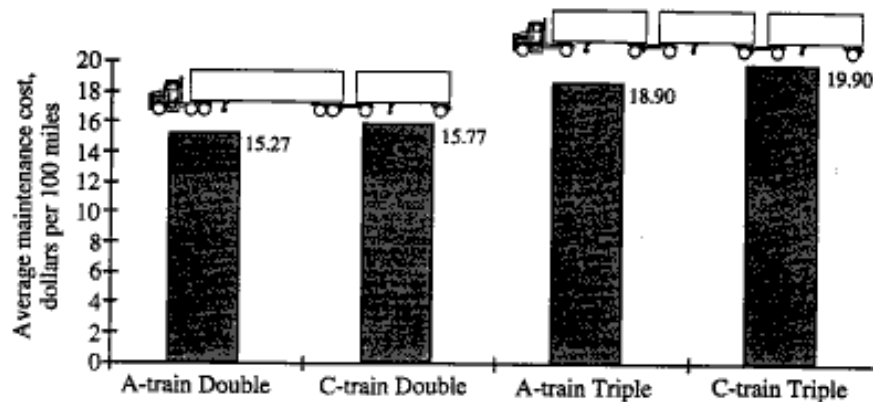
Maintenance costs for LCVs using A-dollies and C-dollies

Replacing A-dollies with C-dollies appeared to increase the overall maintenance costs for double-trailer combinations by about 3 percent and by about 5 percent for triple-trailer combinations. Most of these increases in operating expense resulted from an 80 percent increase in tire wear rates on C-dollies relative to A-dollies. Continuing maintenance cost associated with the unique features of the C-dolly—the double tow bar and its hitches and the self-steering system—appeared minor in relation to increased tire costs. The maintenance expense for operating a single A-dolly was \$1.04 per 100 miles, of which \$0.55 was attributable to tire costs. The comparable figures for C-dollies are \$1.54 and \$0.99, respectively.

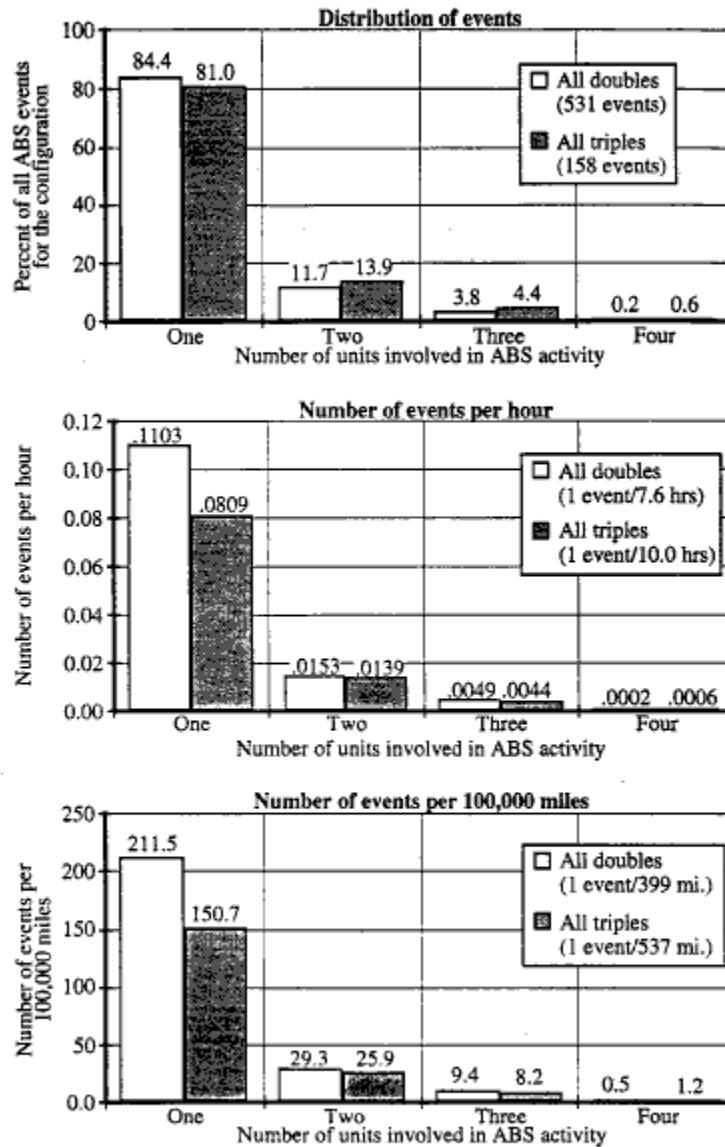
The following conclusions can be drawn based on the three graphs of figure 8.

Figure 8. The occurrence of LCV braking events according to the number of units exhibiting ABS activity during the event

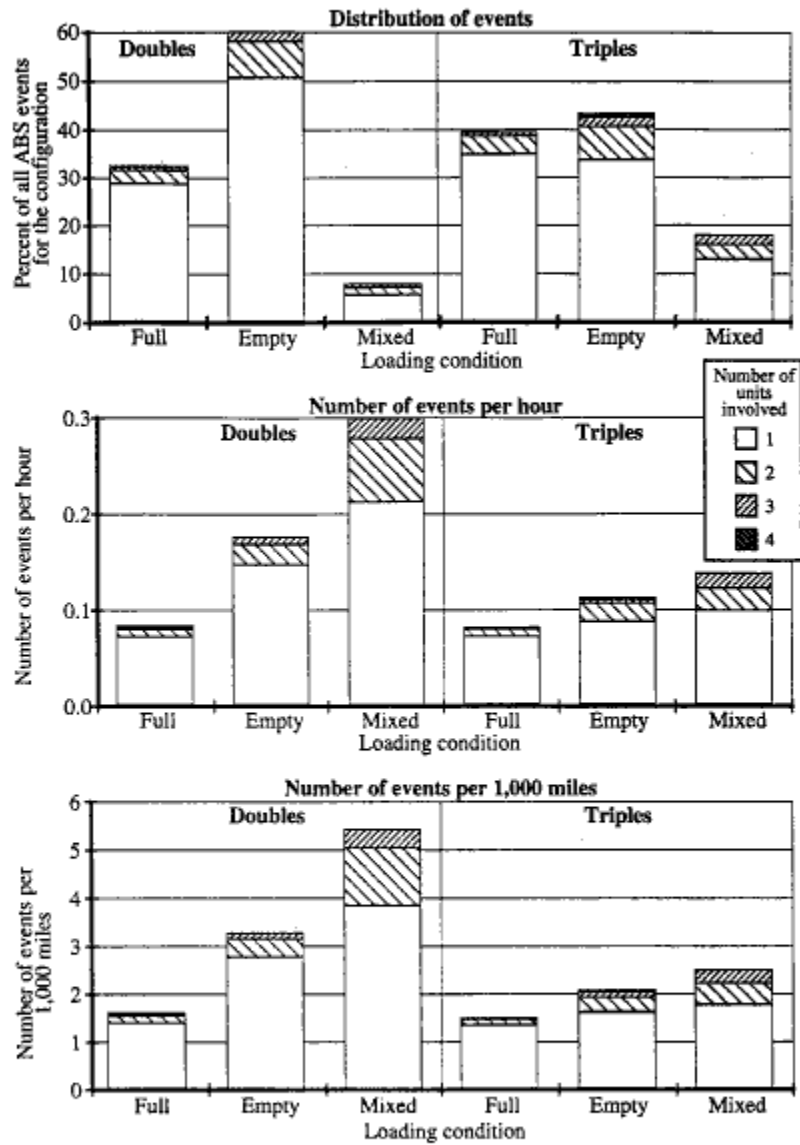
- The *rates* of ABS activity are greatest in vehicles with mixed loading conditions, next largest in vehicles that are empty, and smallest in vehicles that are fully loaded.

Figure 9. The occurrence of LCV braking events according to loading condition and the number of units experiencing ABS activity

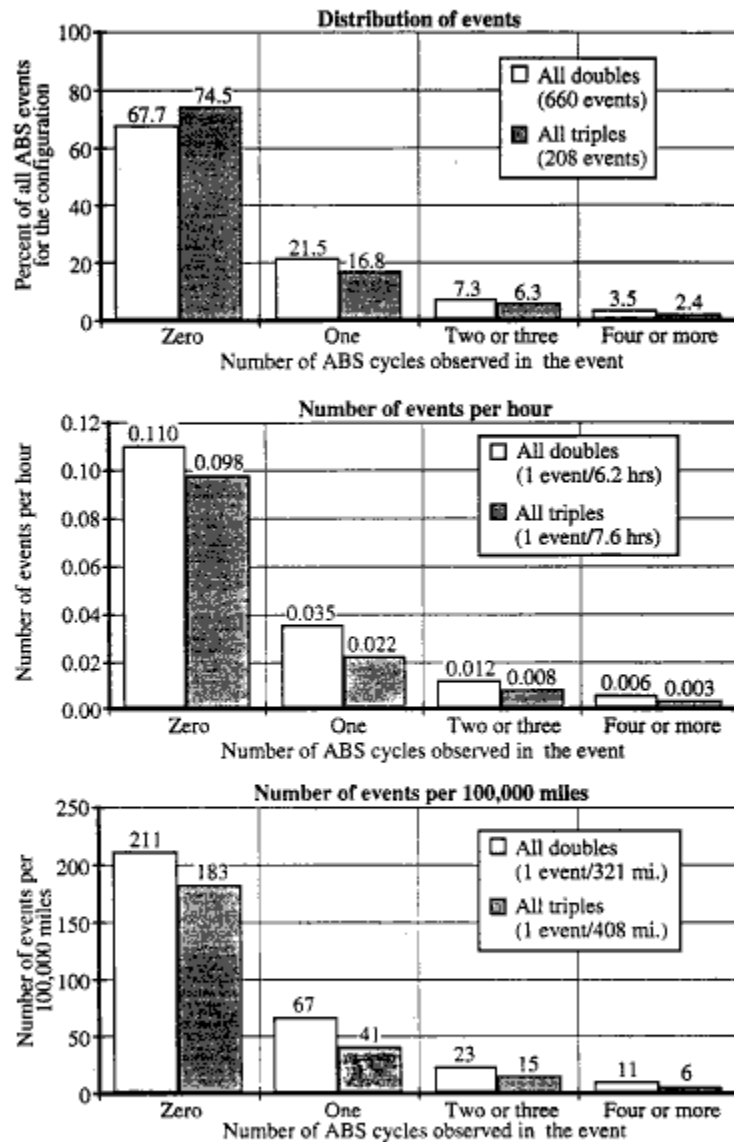
- Approximately 70 percent of the (intraunit) ABS events observed did not show substantial cycling response of brake chamber air pressure and wheel speeds. This is in spite of the fact that the threshold of activity required to initiate recording would, itself, filter out a great deal of insignificant activity. From one quarter to one third of the events observed do involve cyclic response. Events with two or three cycles made up about 7 percent of the observations and events with four or more cycles were about 3 percent of the observations.

Figure 11. The occurrence of intraunit braking events according to the number of ABS cycles observed during the event

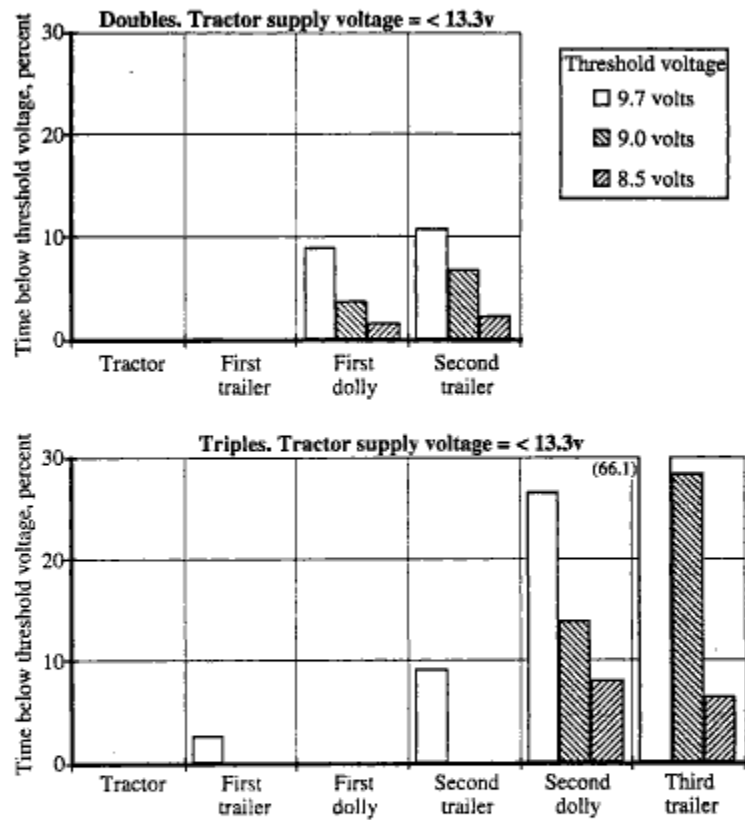
Figure 19. Percentage of time during ABS braking events when the brake-light-circuit voltage was less than the indicated threshold voltage for LCVs with incandescent brake lamps and supply voltages less than 13.3 volts

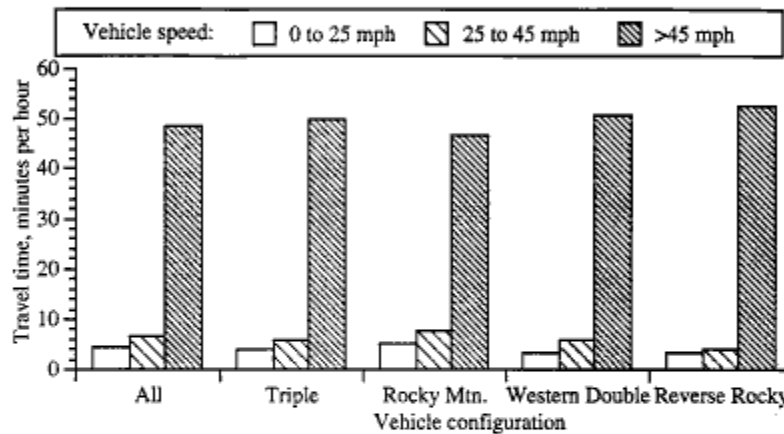
**Figure 21. Distribution of travel time by configuration and speed**

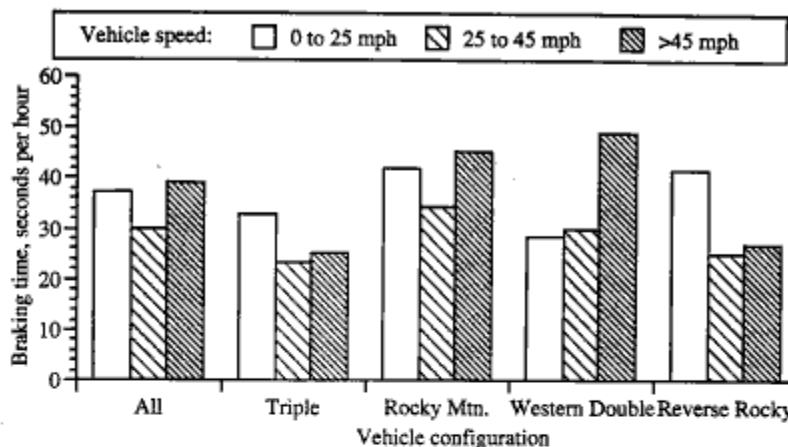
Figure 22. Distribution of brake application time by configuration and speed

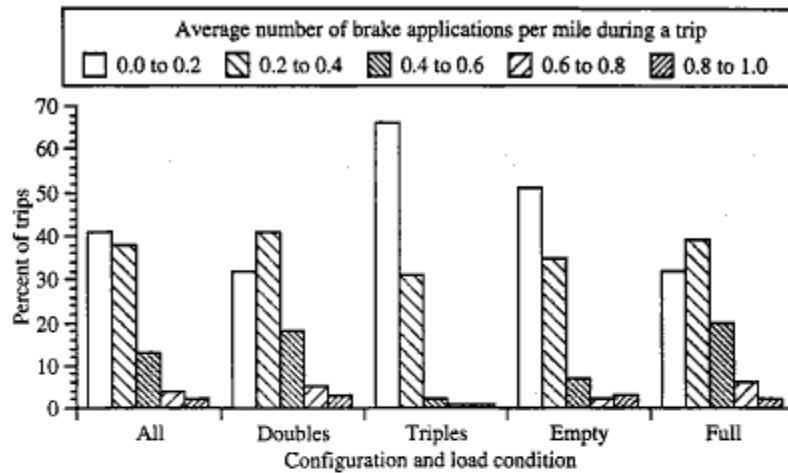
**Figure 23. Distribution of brake applications per mile by configuration and load condition**

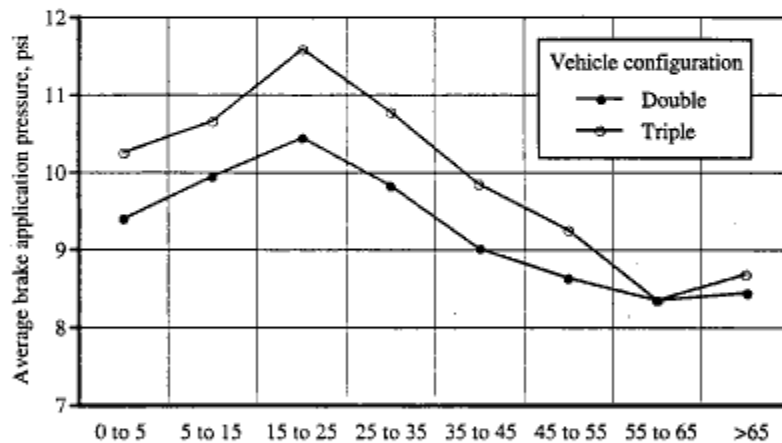
Figure 25. Average brake application pressure as a function of speed for double- and triple-trailer LCVs

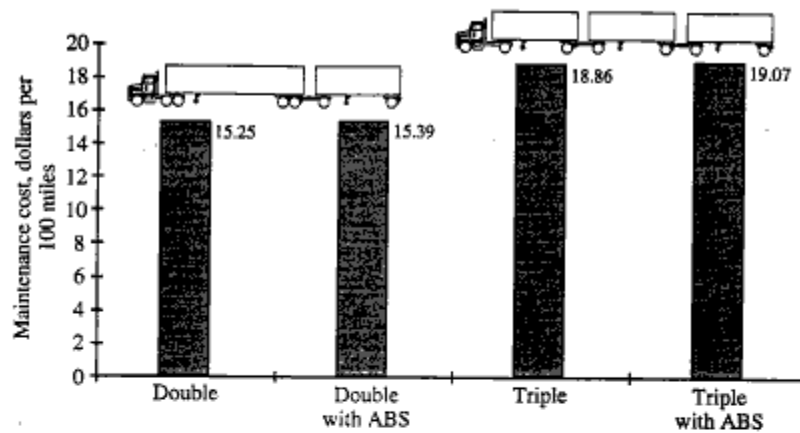
Figure 28. Maintenance costs for LCVs with and without ABS

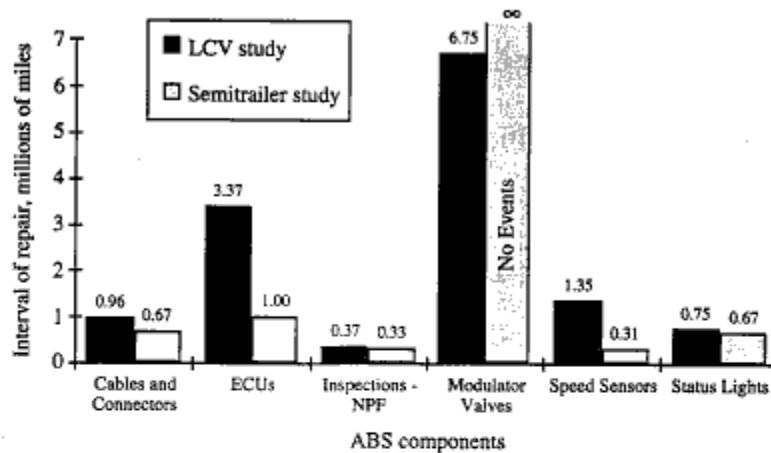
Figure 32. Summary of ABS component repair rates from the LCV study and the previous semitrailer study

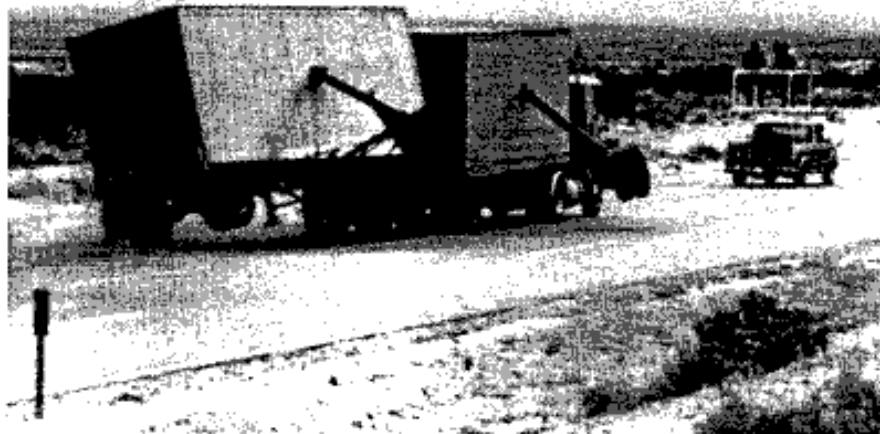
**Figure 35. The rear trailer of a western double approaching rollover in a rapid lane change maneuver**

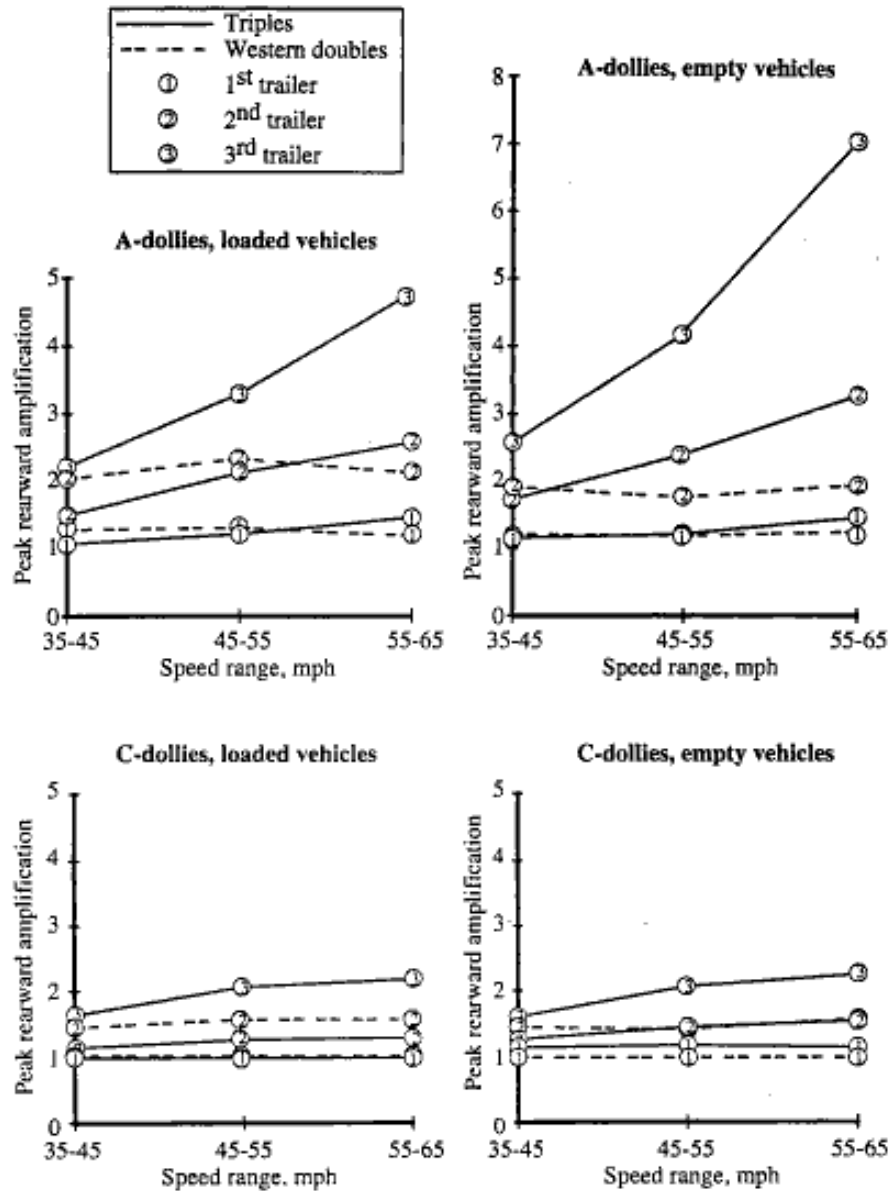
Figure 39. Peak rearward amplification of short-trailer doubles and triples as a function of loading, dolly type, and speed

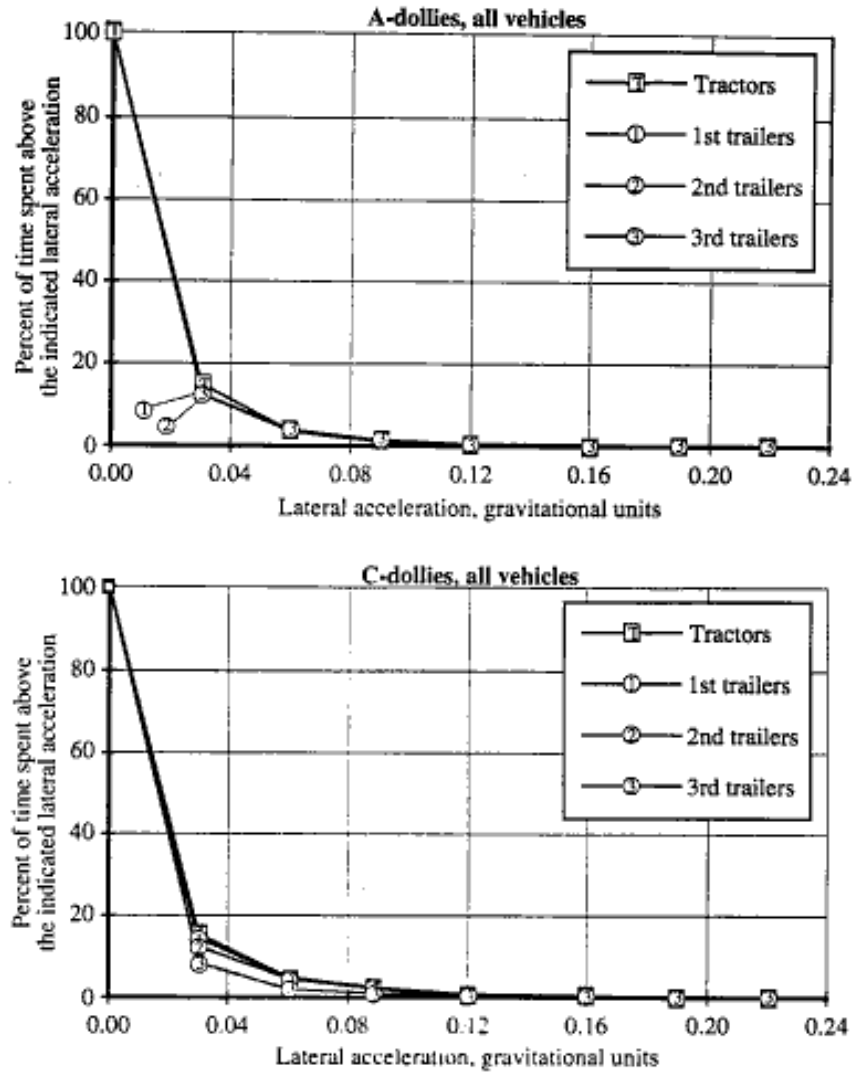
Figure 41. The lateral acceleration experience of all vehicles in the LCV study distinguished by dolly type (speeds above 45 mph)

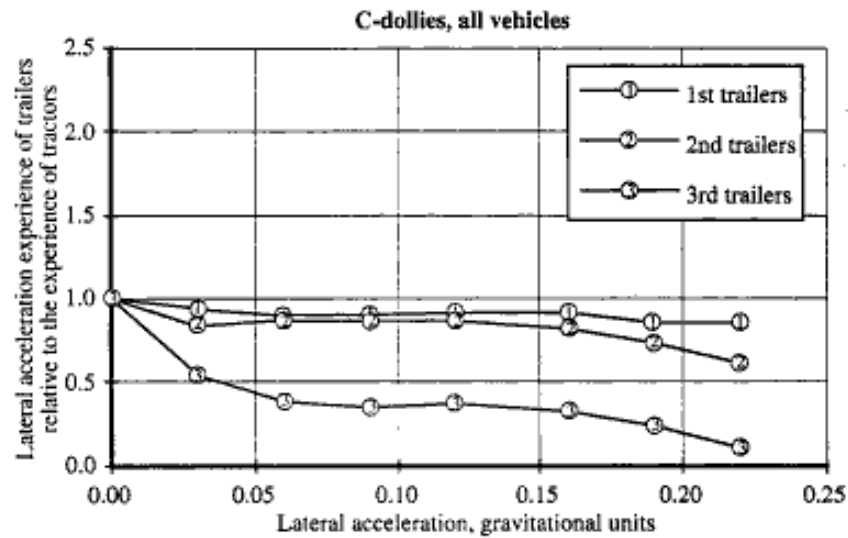
Figure 43. The lateral acceleration experience of all trailers relative to the lateral acceleration of tractors distinguished by trailer position and dolly type (speeds above 45 mph)

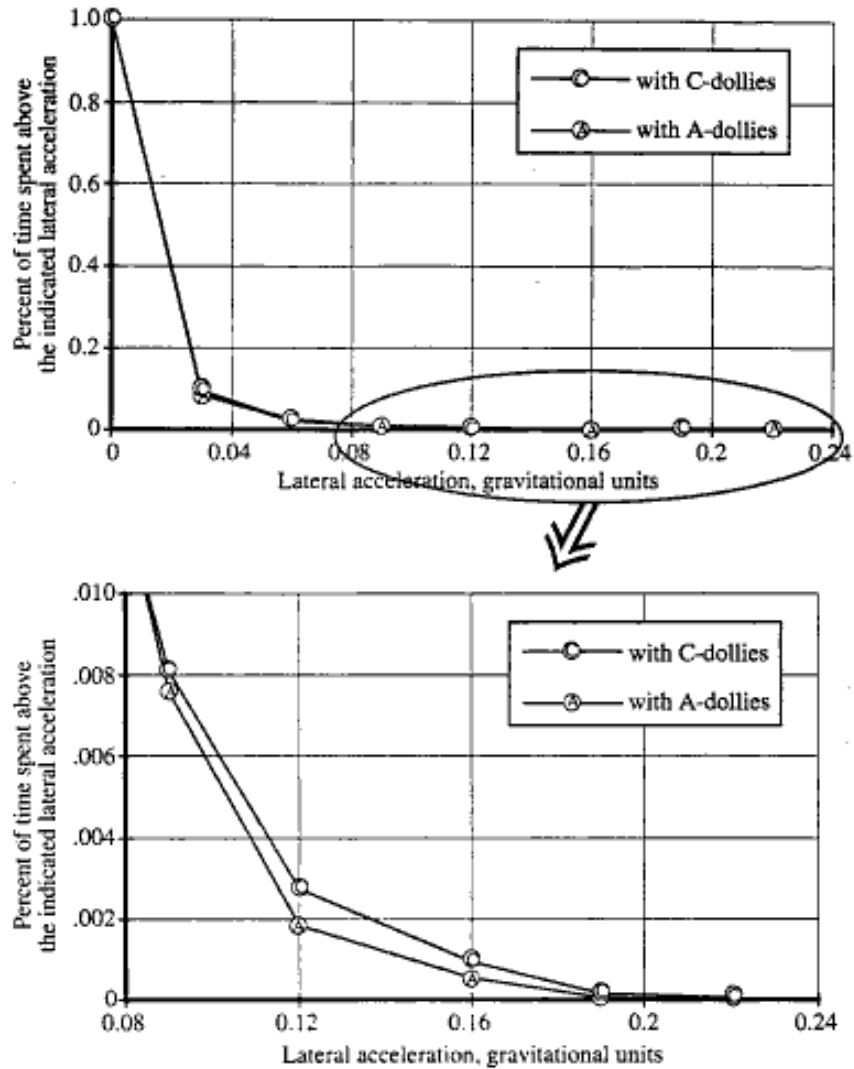
Figure 45. Comparison of the lateral acceleration experience of the tractors of triples when pulling A-dollies and C-dollies, respectively (speeds above 45 mph)

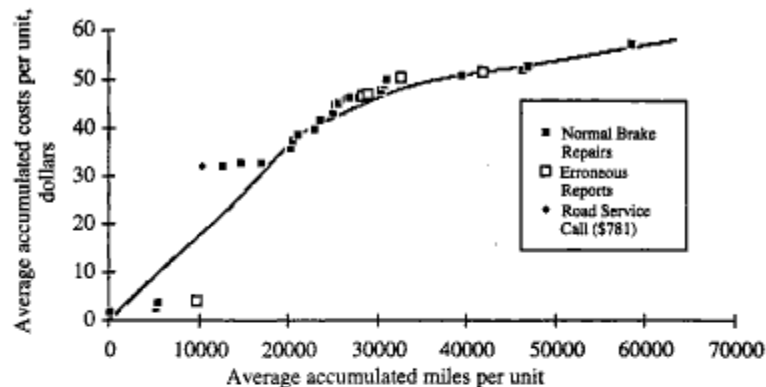
**Figure 53. Average accumulated costs per unit for the maintenance of the brake system of C-dollies**

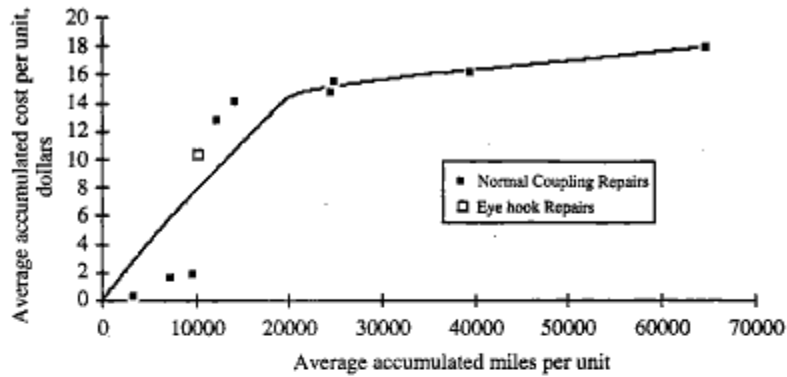
Figure 54. Average accumulated costs per unit for the coupling system of C-dollies

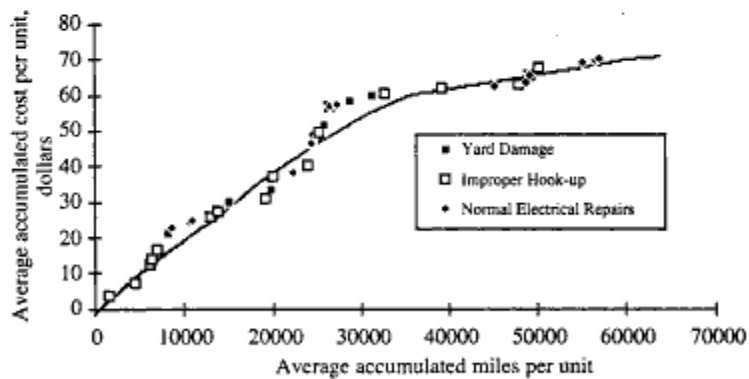
Figure 55. Average accumulated cost per unit for the maintenance of the electrical system of C-dollies

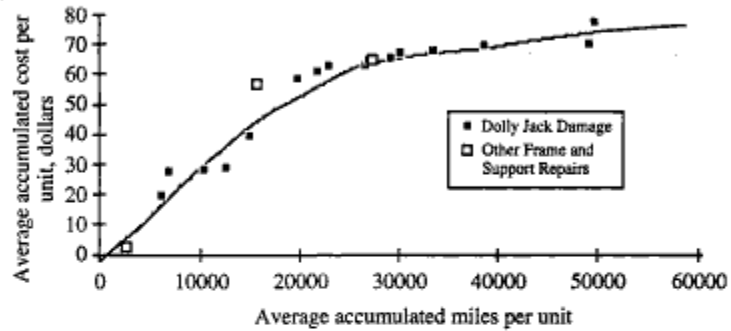
Figure 56. Average accumulated costs per unit for the frame system of C-dollies
